CITY OF DAVENPORT

City Hall Masonry Restoration

November 18, 2021

BUILDING ENVELOPE ASSESSMENT

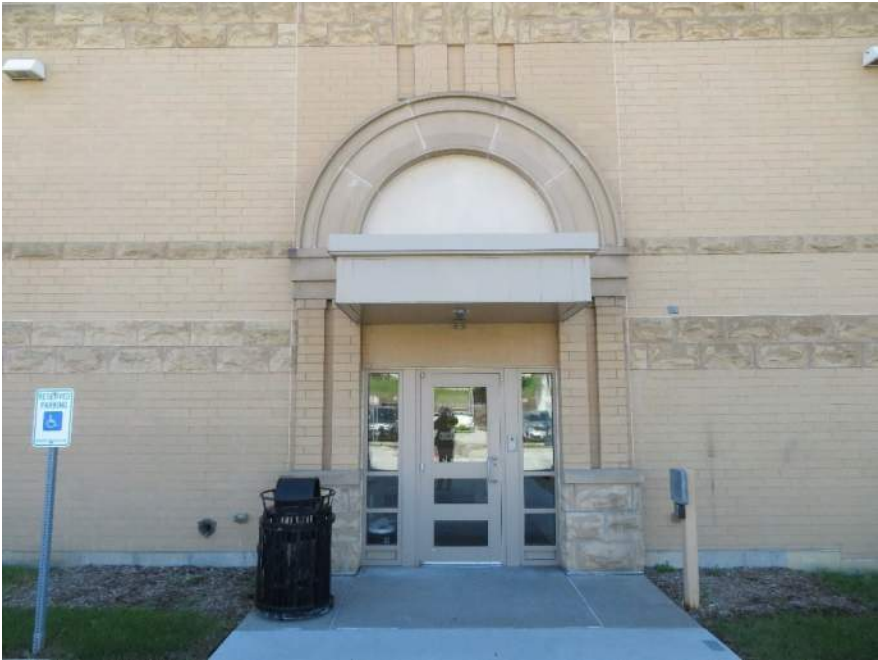
North Elevation

The masonry on the north elevation of the building appears to be in good condition. The mortar joints are continuous with no perceivable gaps or cracks in the mortar. The sealant in the control joints is in good condition.

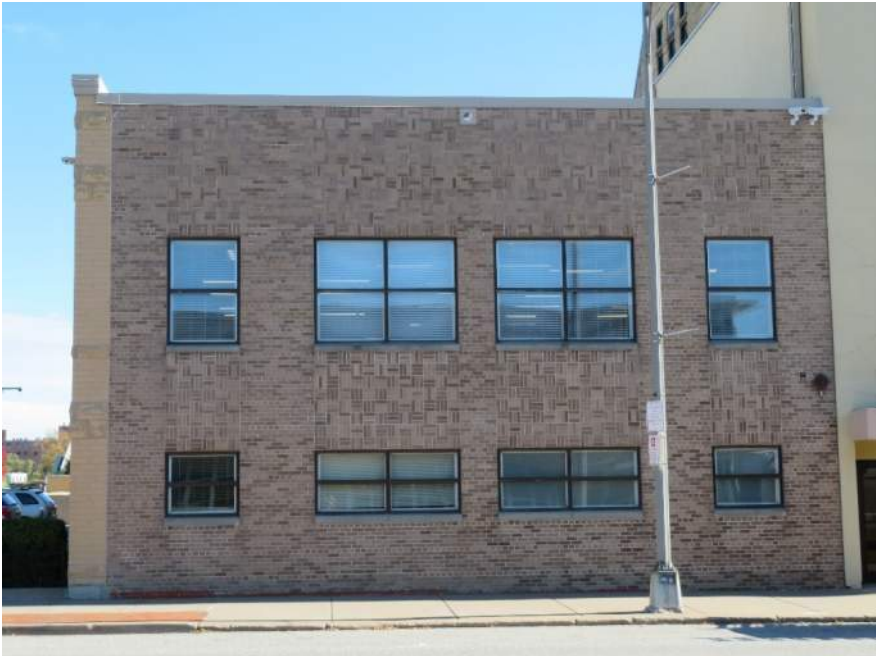
West Elevation

The EFIS on the east elevation is in good condition. The EFIS on the west elevation is in poor condition. There are many cracks in the face of the EFIS.

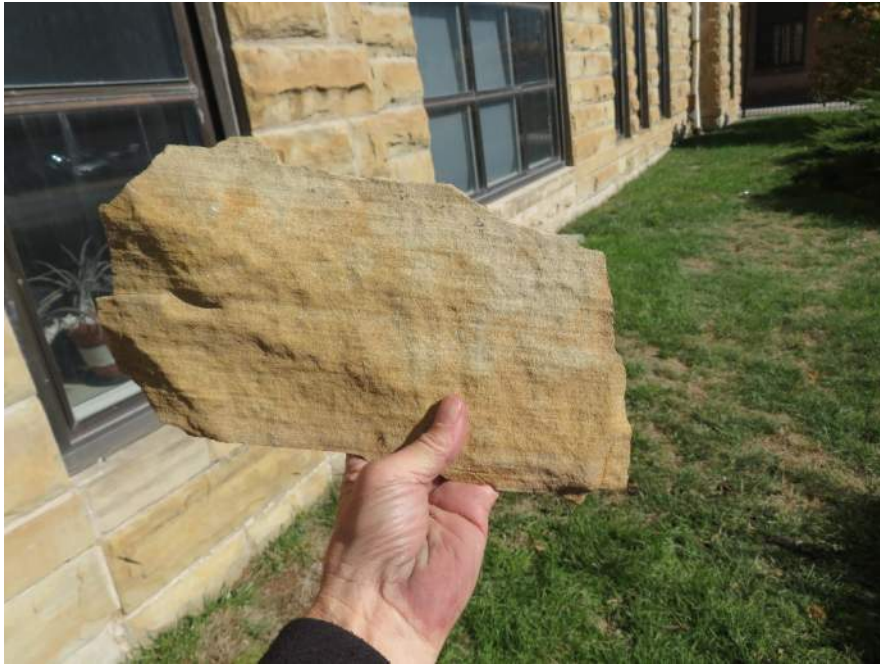
The sandstone masonry blocks, and ornamental sandstone are in fair condition, given the age of the building. The mortar joints are deteriorated, and sandstone faces are spalling and deteriorating. The base of the sandstone is being deteriorated by salt along sidewalks and driveways. The sandstone has been repaired in the past. We have determined the repairs were done at least 20 years ago. The repairs are still in good condition; however, they are pinkish in color and do not blend with the rest of the stone. Today's patching materials have a wide variety of colors to help blend in better. The face brick on the west and east elevations is in fair condition. The mortar joints are deteriorated, stone windowsills are staining and need joint sealant. Steel lintels at the windows are rusting.

Spalled sandstone

- Clean all sandstone and face brick masonry
- Caulk all stone coping caps
- Patch all spalling and deteriorating sandstone masonry. Approx. 430 SF
- Crack inject broken sandstone. Approx. 25 LF
- Tuckpoint deteriorated mortar joints. Approx. 12,000 SF
- Replace sealant at all windows
- Scrape and paint steel lintels
- Patch and skim coat cracked EFIS
- Paint metal clock faces on clock tower
- Provide sealer on all sandstone masonry
- Replace all scuppers and downspouts

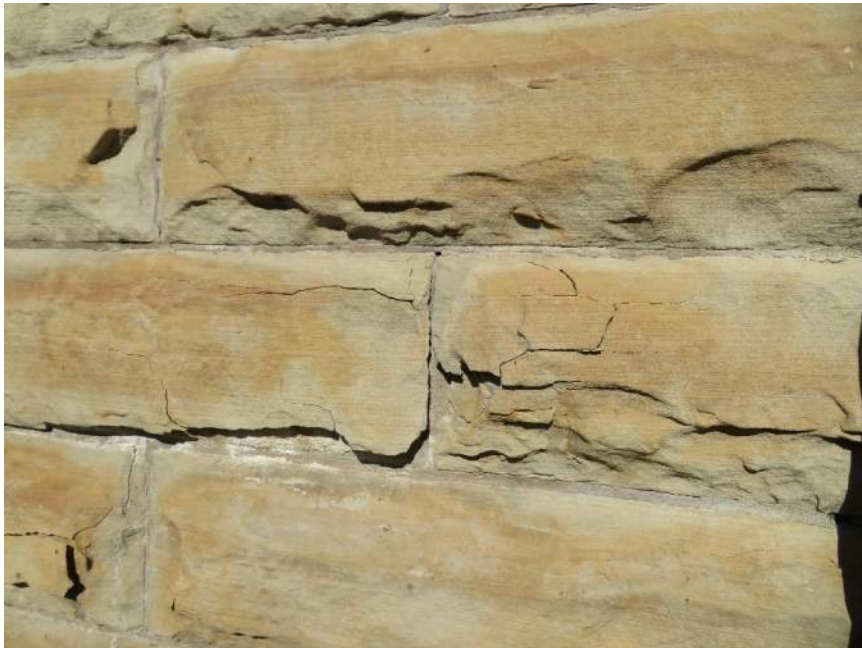
Spalling sandstone

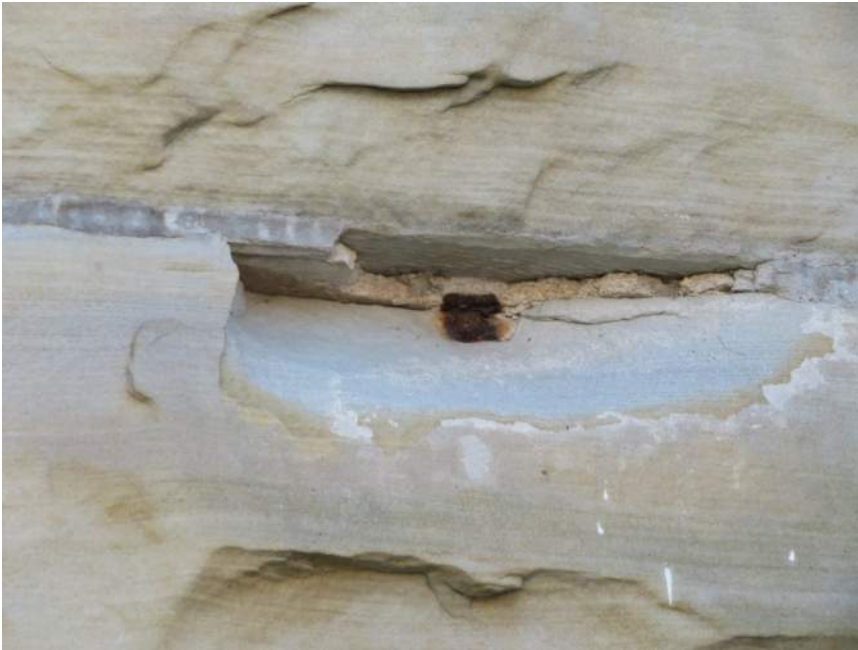
Rusted stone anchors

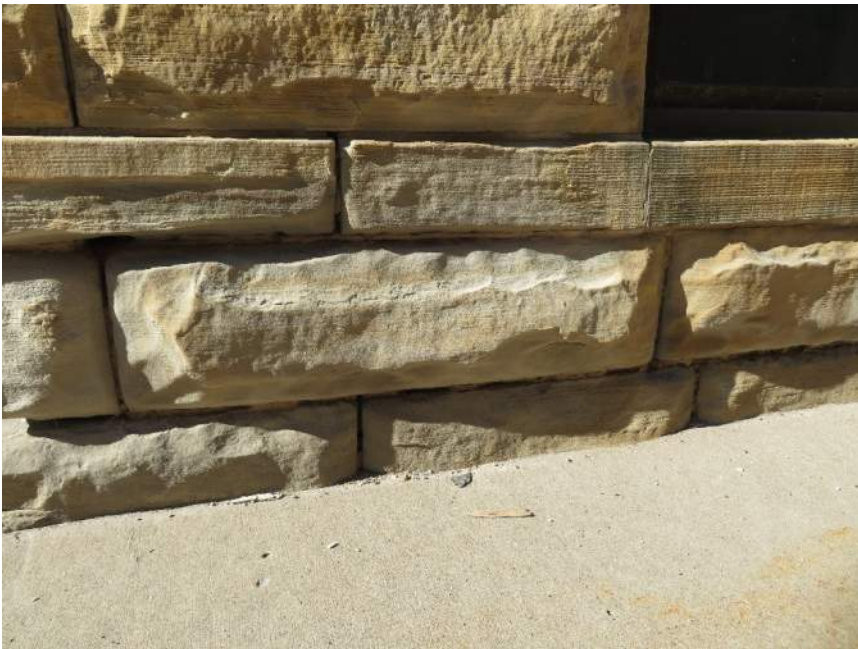
Deteriorated sandstone and mortar joints

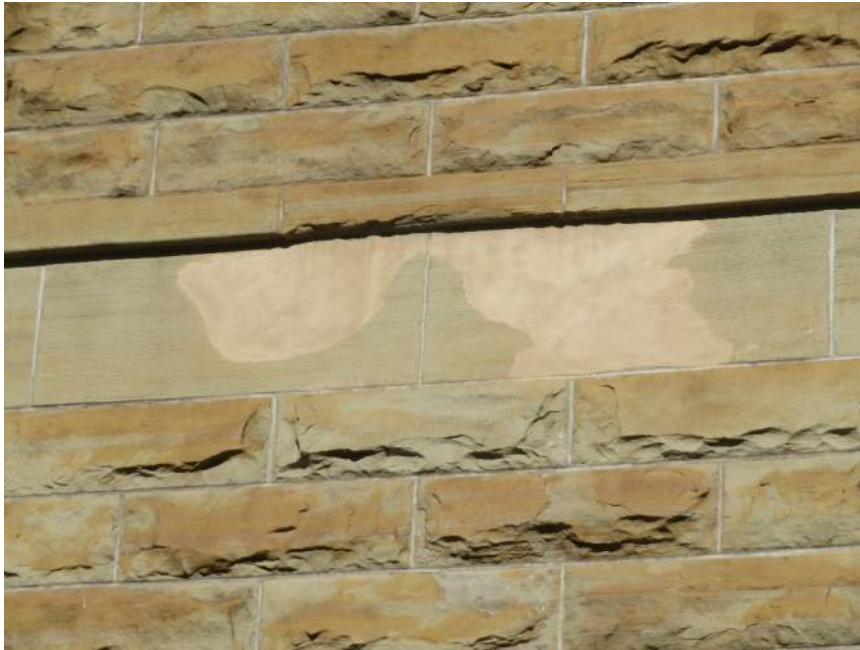
Previous patches

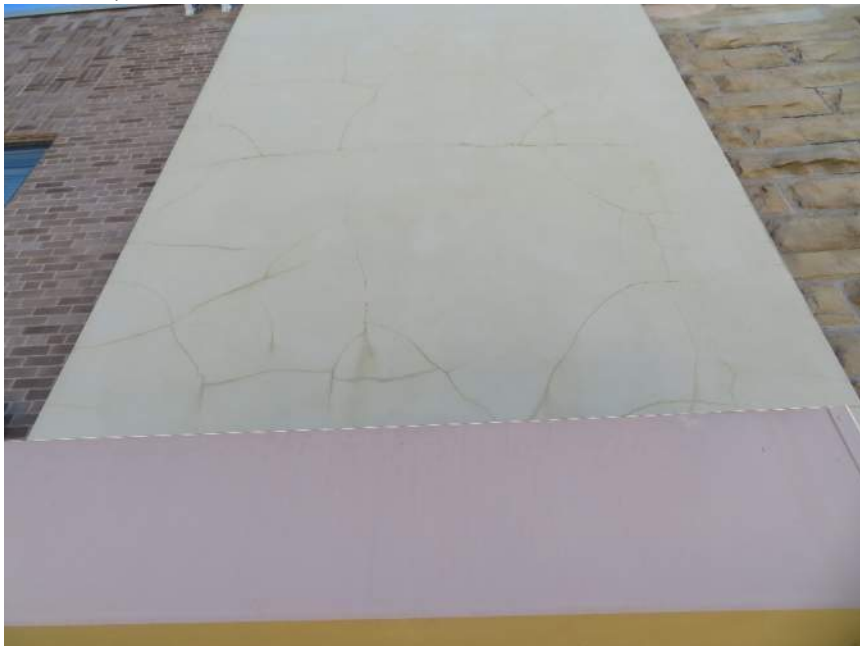
Cracks in EFIS

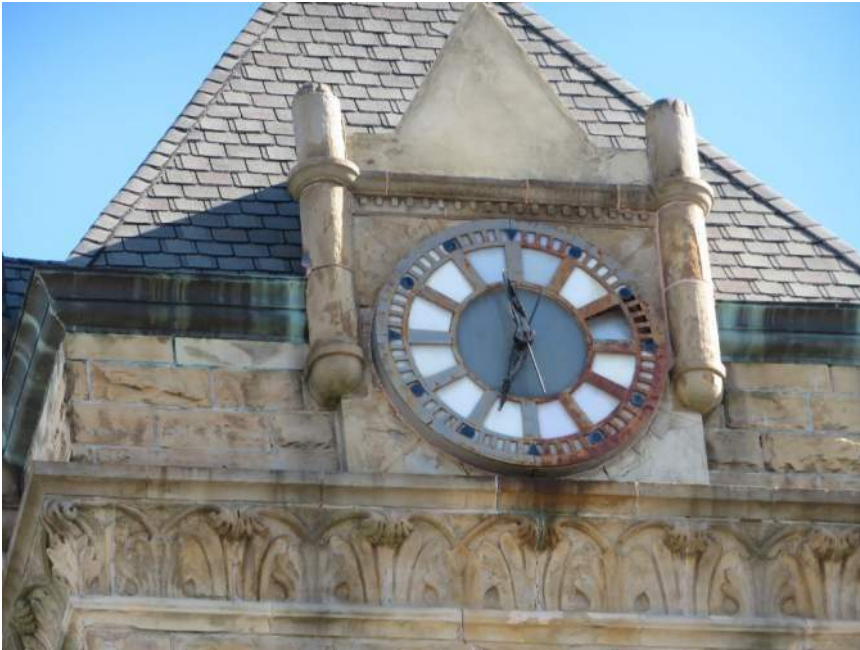
Rusted face of clock
