HISTORIC PRESERVATION COMMISSION MEETING

A. Case COA22-02: Request for exterior restoration at 619 West 6th Street. The Techentin-Best House is listed as a contributing structure in the Hamburg Local Landmark Historic District. Alexander F Gorbach Revocable Trust, petitioner. [Ward 3]

B. Case COA22-03: Request to reconstruct the retaining wall behind 510 West 6th Street. The retaining wall is located within the Hamburg Local Landmark Historic District. City of Davenport, petitioner. [Ward 3]

# RETAINING WALL REPLACEMENT

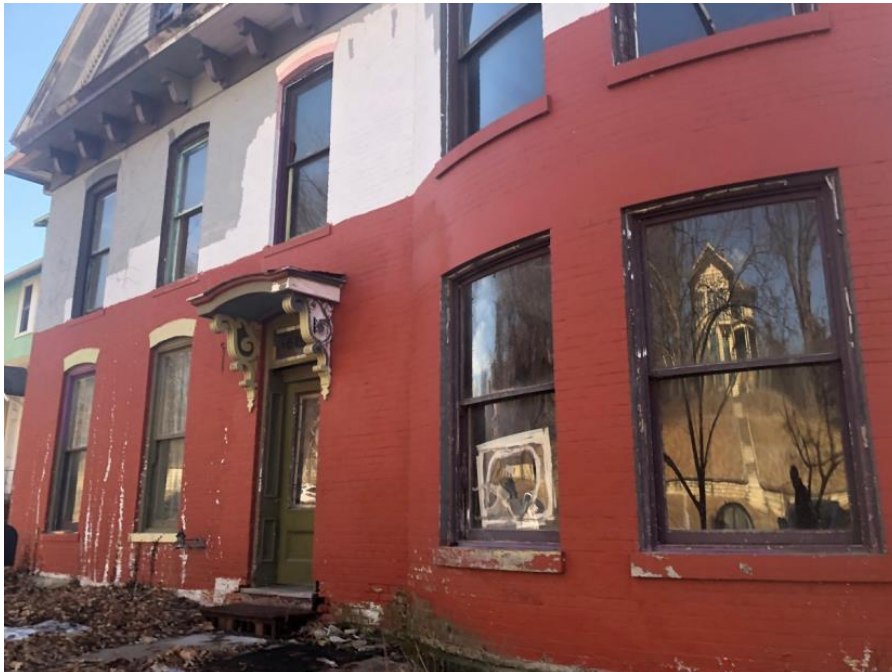
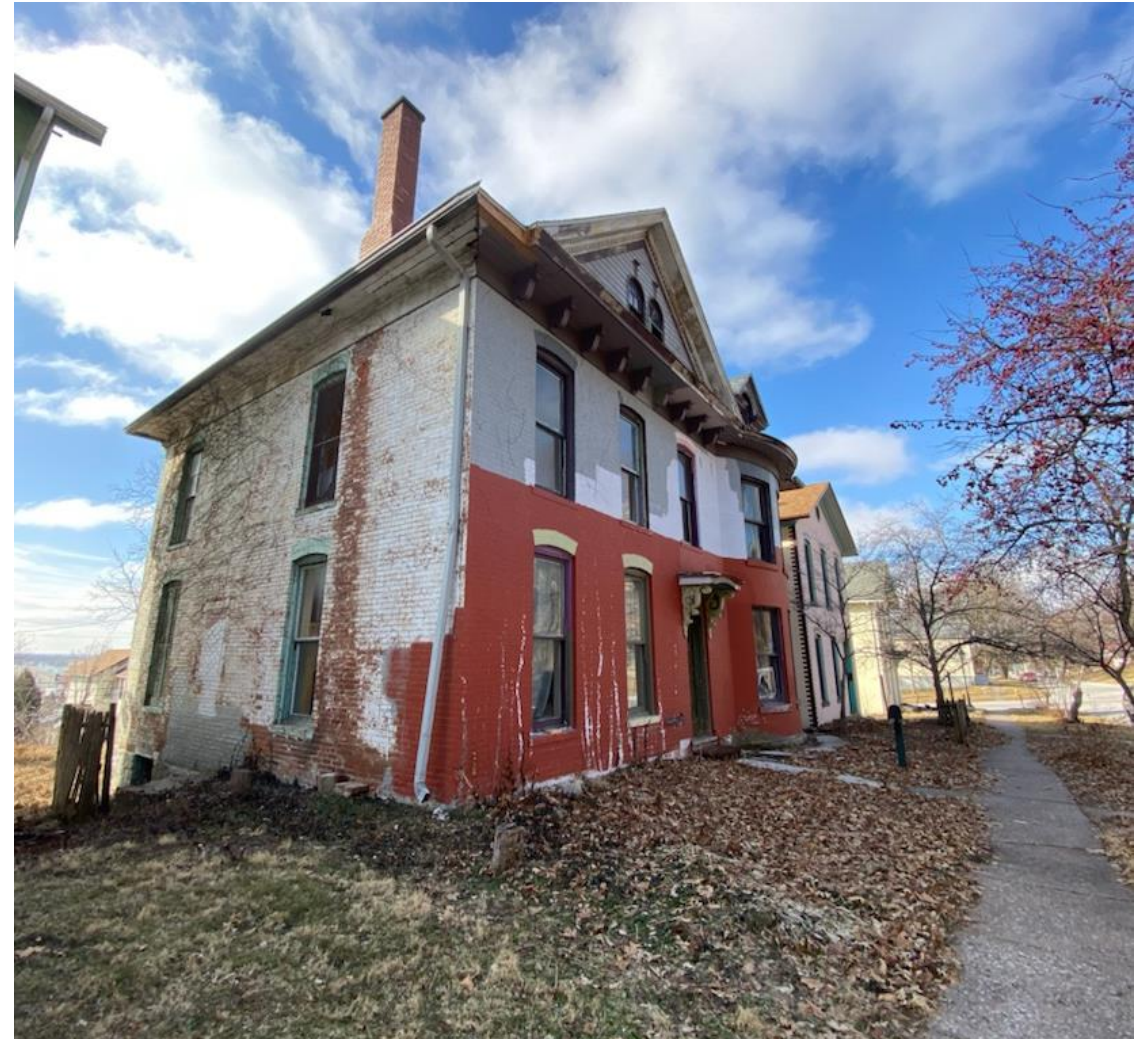
# Project Scope-Masonry

- Paint brick a uniform color.
- Brick has been painted several times in its history.
- Chimney's to remain unpainted.
- Brick to be cleaned by hand scraping with soft brushes.

2. **Paint the exterior brick a uniform color.** The existing condition consists of red, gray, and white paint tones. Painting brick generally detracts from the historic character of a building. However, the Techentin-Best House has been painted several times in its history. Therefore, painting with a historically appropriate color will be more sympathetic to the structure and fitting with the character of the Hamburg Historic District. The applicant does not intend to paint the two chimneys, which have never been painted before.

The applicant has verified that the Secretary of the Interior's Standards for Rehabilitation will be followed during the cleaning and repainting of exterior masonry. Hand scraping using soft brushes will be used to remove loose paint. The standards recommend the following when conducting masonry work:

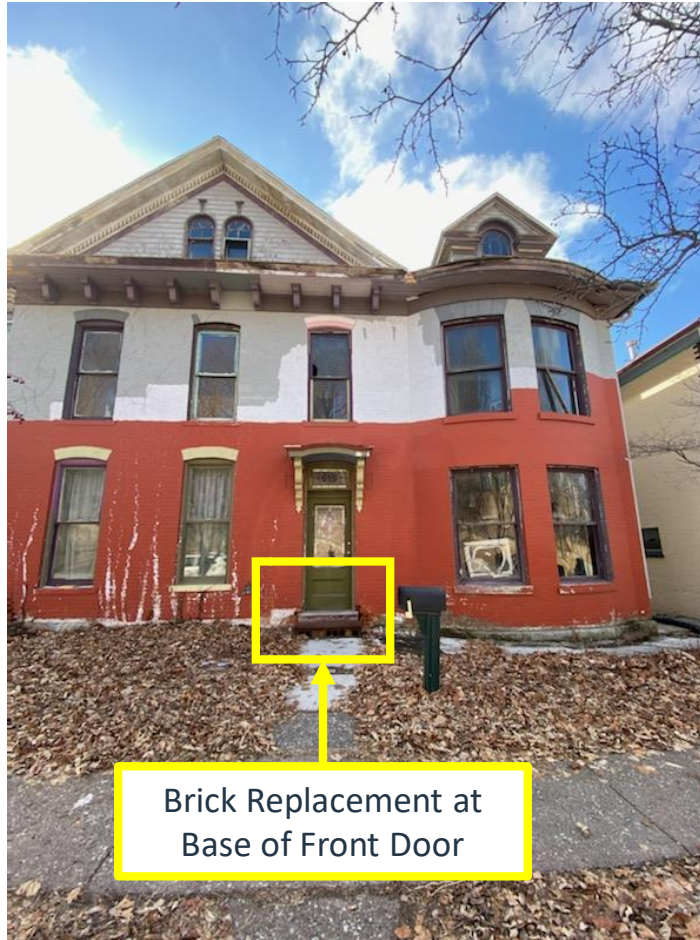
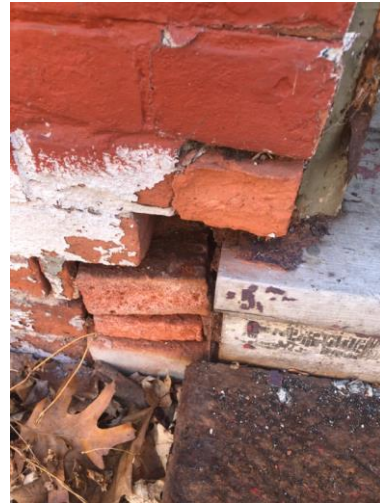
Base of Front Stoop

# Tuckpoint & Replace Missing Brick

- Soft mortar proposed.
- Scope of tuckpointing limited to the base of the front door and a hole in the rear elevation.

1. **Tuckpoint loose and missing brick by the front step and back door utilizing soft mortar and brick located on the property.** The available brick is believed to be original as

it closely resembles portions of unpainted masonry on the home. The brick replacement and tuckpointing is limited to the base of the front door step and a hole in the rear of the home. Typically, city staff would recommend a mortar analysis when performing tuckpointing on a historic structure. However, given the limited scope of work, the proposed soft mortar is an acceptable material.

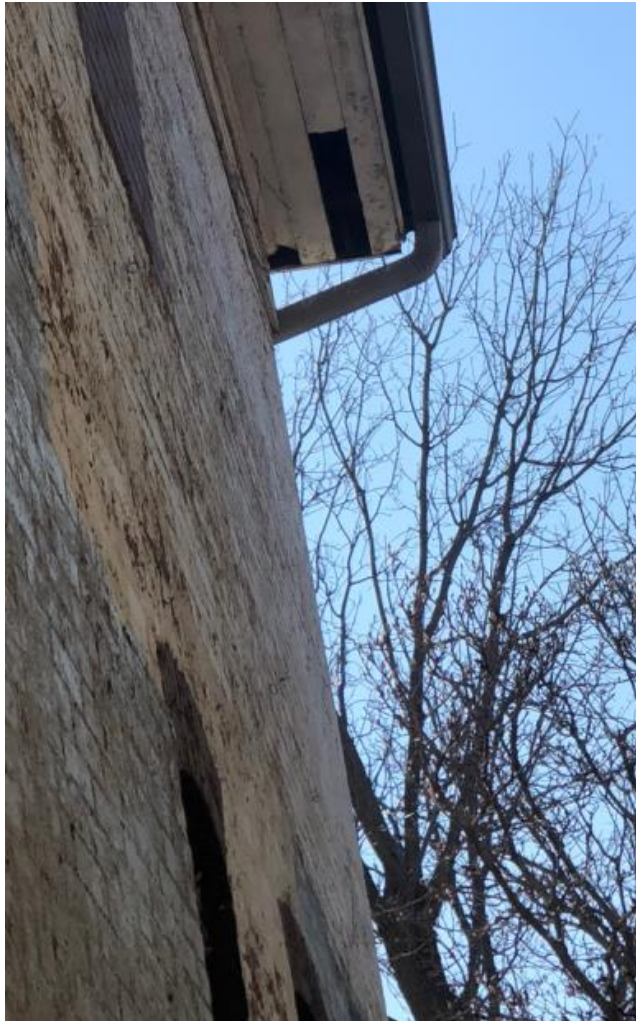
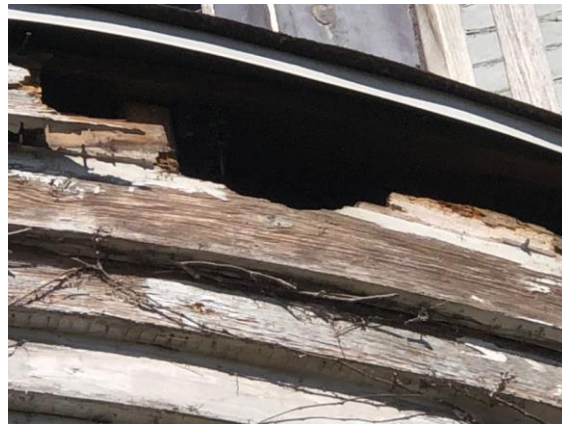
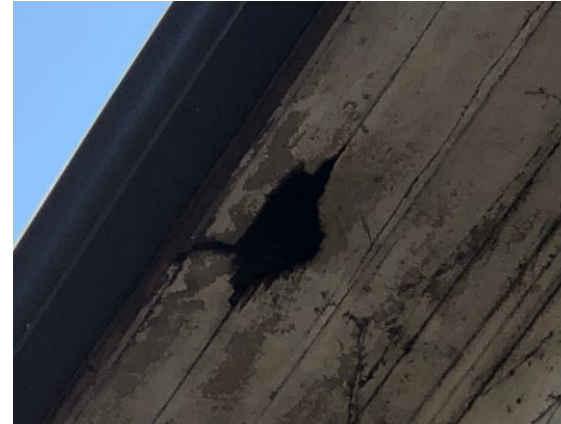
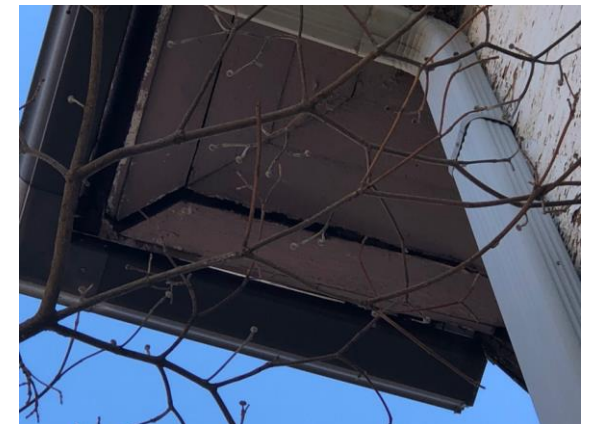
# Repair & Replace Soffit

- Repair & replace missing soffit boards with 1"x4" lumber.
- Deteriorated boards to be replaced with pine lumber.
- New boards will be sized to match the existing soffit dimensions.
- Paint all woodwork & siding.

3. **Repair and replace missing soffit boards with 1"x4" lumber.** Soffit boards will be repaired rather than replaced where possible. Deteriorated boards will be replaced with either pine or treated pine lumber, depending on moisture levels. The new boards will be sized to match the existing soffit dimensions.

Yes. The 1"x4" is approximate and will need to be adjusted on site to fit. Only fully damaged boards will be replaced (otherwise just the damaged sections will be fixed/replaced). I intend to use pine or treated pine, depending on moisture exposure.

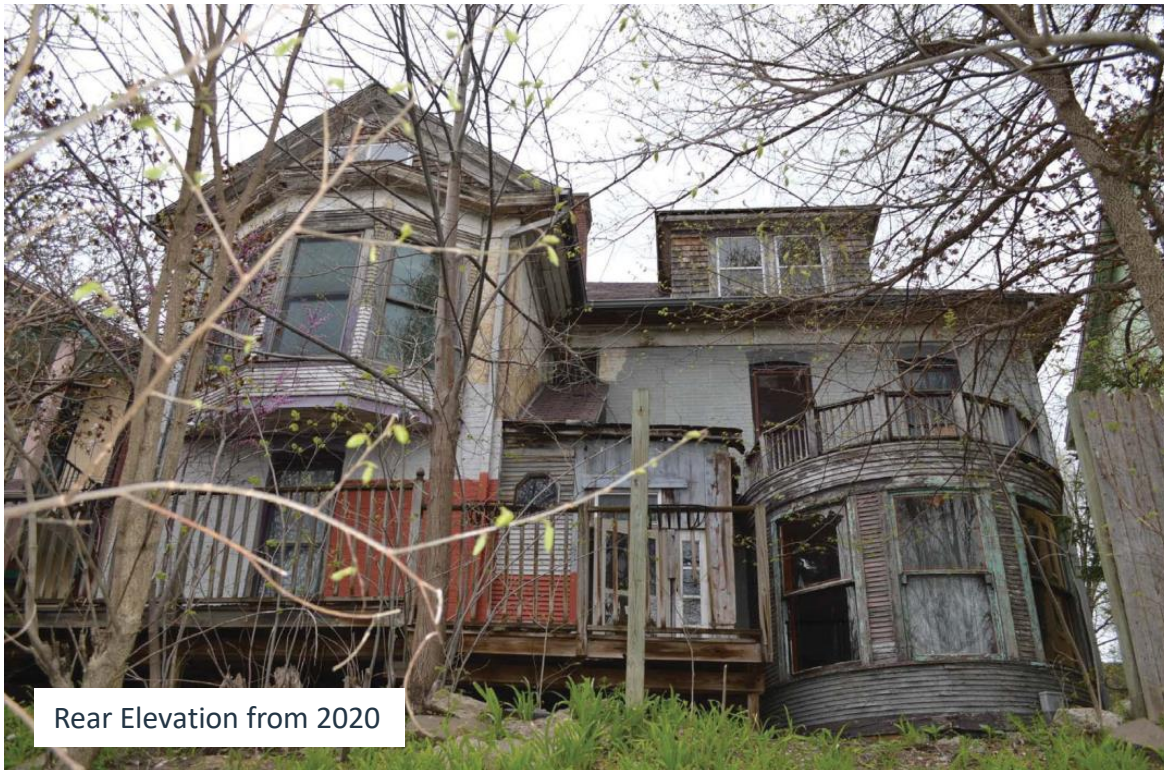
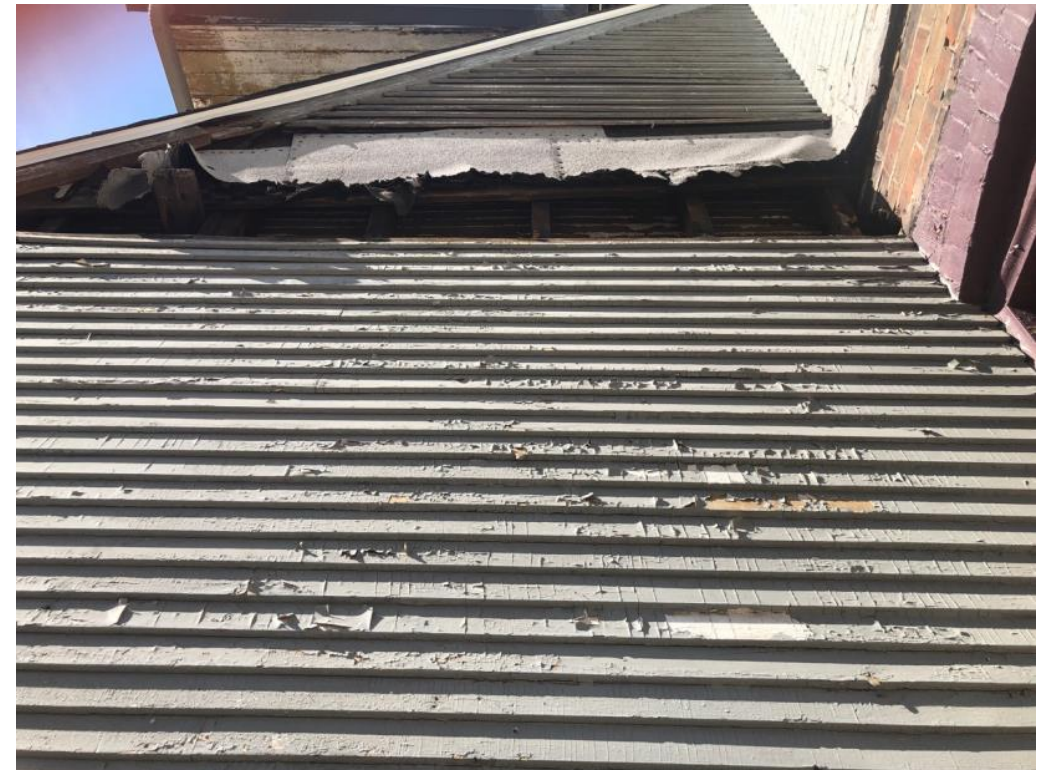
# Repair & Replace Siding

- Preserve & refurbish existing cedar plank siding in the rear of the home.
- Replace missing/deteriorated siding with matching cedar plank.
- New boards to be overlapped to match dimensions of historic plank (3.5" tall).

4. **Repair/replace missing siding on the back of the house with matching cedar plank.** The current cedar siding is tapered approximately 3.5 inches tall. Where deterioration is severe, boards will be replaced with a matching cedar plank that will be overlapped for consistency in dimensions. Otherwise, existing boards in good condition will be refurbished and preserved. On the curved bay, the larger trim pieces are kerf bent. The owner intends to replace damaged sections in the same manner.

Yes. The current cedar siding is tapered ~3.5" tall. I will match the overlap to be consistent with existing siding. On the curved bay, the larger trim pieces are currently kerf bent and I intend to replace damaged sections in the same manner.

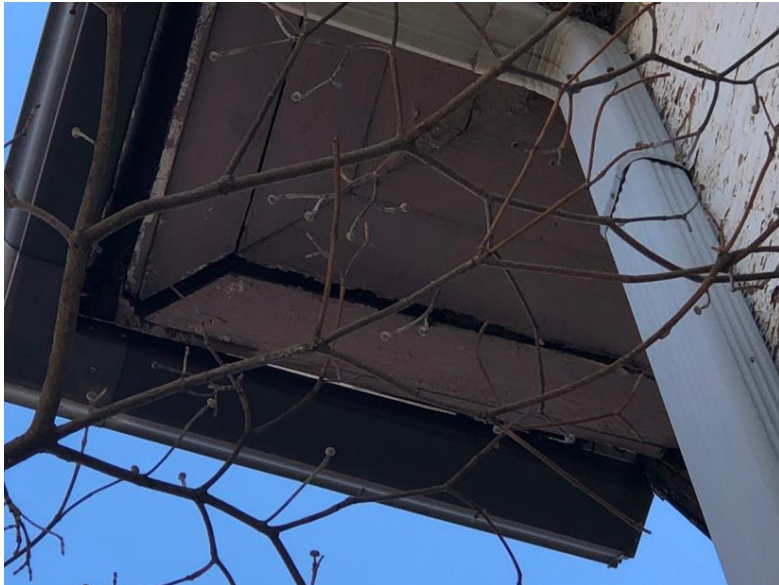
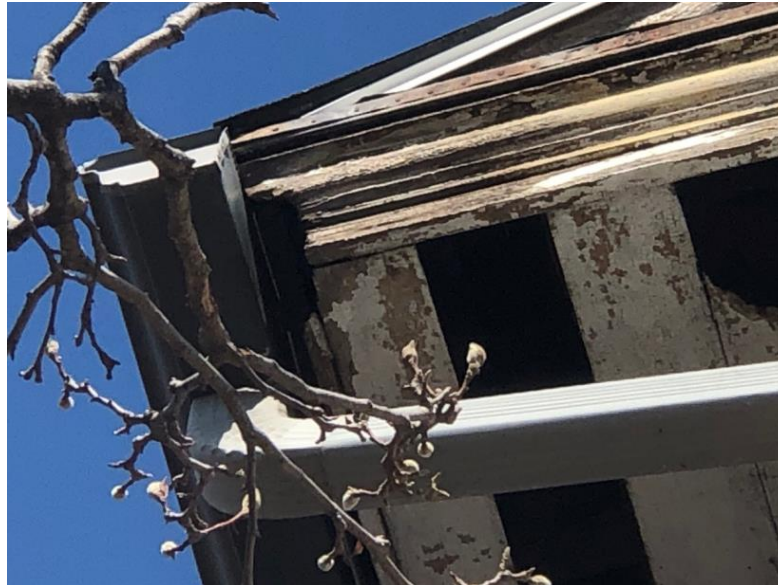
# Gutter Replacement

- **Existing Gutters:** K-Profile Aluminum (Non-original) (Varying Colors Used Throughout the Roof)
- **Replacement Gutters:** K-Profile Aluminum
- New Gutters to be a Uniform Color

7. **Replace gutters with matching K-profile gutters.** The existing gutters on the home are nonoriginal k-profile aluminum gutters. The proposed replacement gutters will match the material and profile of the existing, but in a uniform color. Similar to the brick, the current gutters vary between shades of gray, white, and red.

Current gutters are K style and are aluminum. I intend to replace them with matching material (the current color is not consistent gray in some areas and white or red in others, so I will match ).

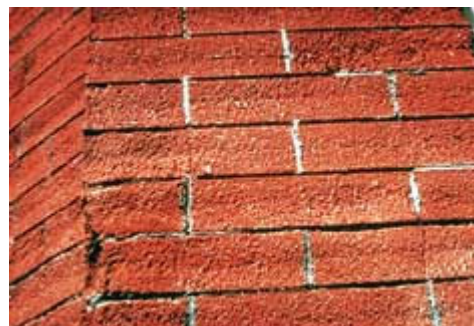
**Historic brick damaged by sandblasting.**

Sandblasting brick or stone surfaces using dry or wet grit or other abrasives. These methods of cleaning permanently erode the surface of the material and accelerate deterioration.

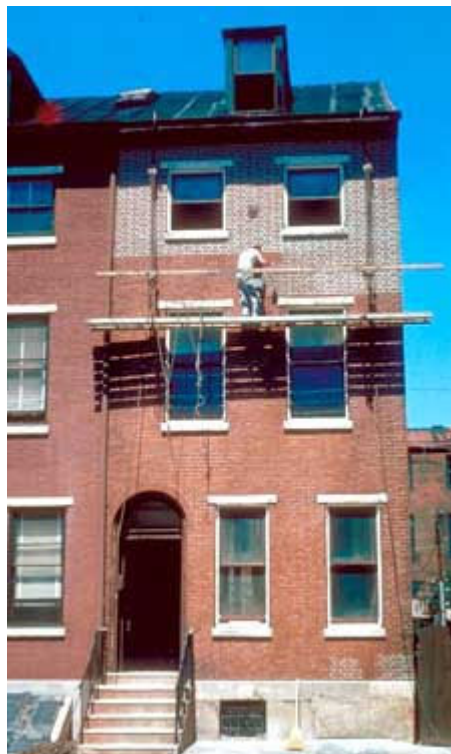
Removing nondeteriorated mortar from sound joints, then repointing the entire building to achieve a uniform appearance.

Loss of the historic character due to insensitive repointing.

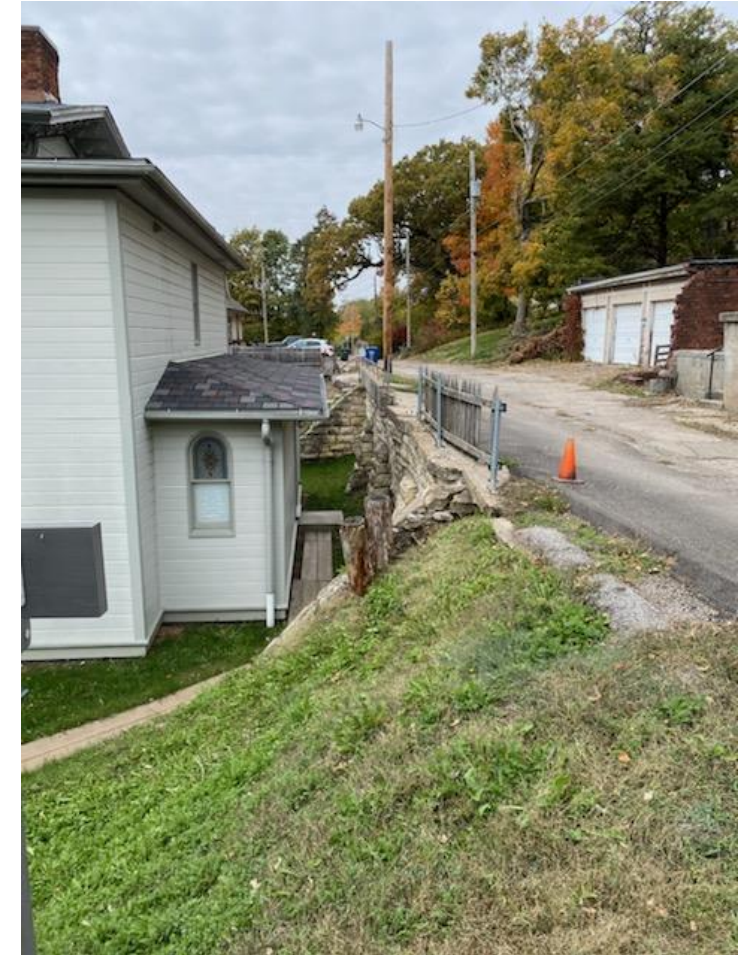
Approximately 7 ft. between the Home and the Wall

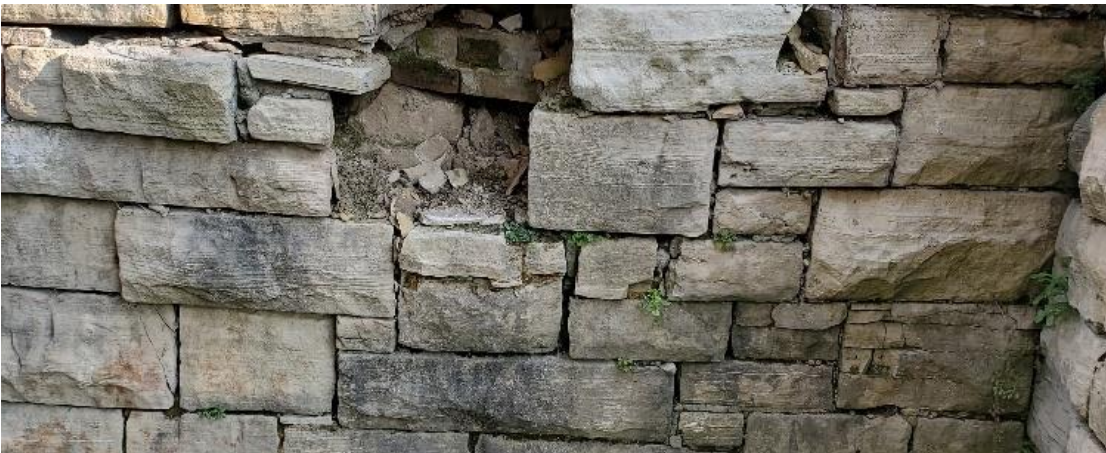
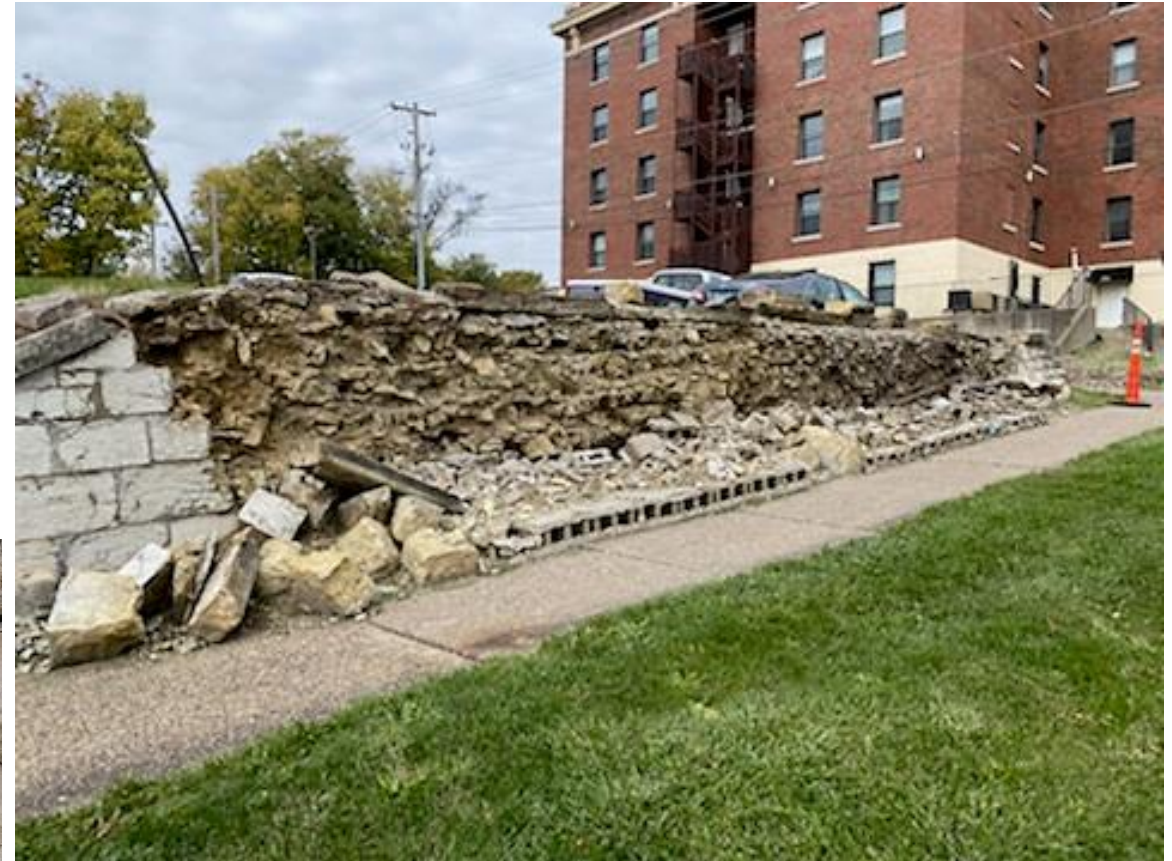
Example: Failed Retaining Wall  
at East 6<sup>th</sup> Street & Iowa Street

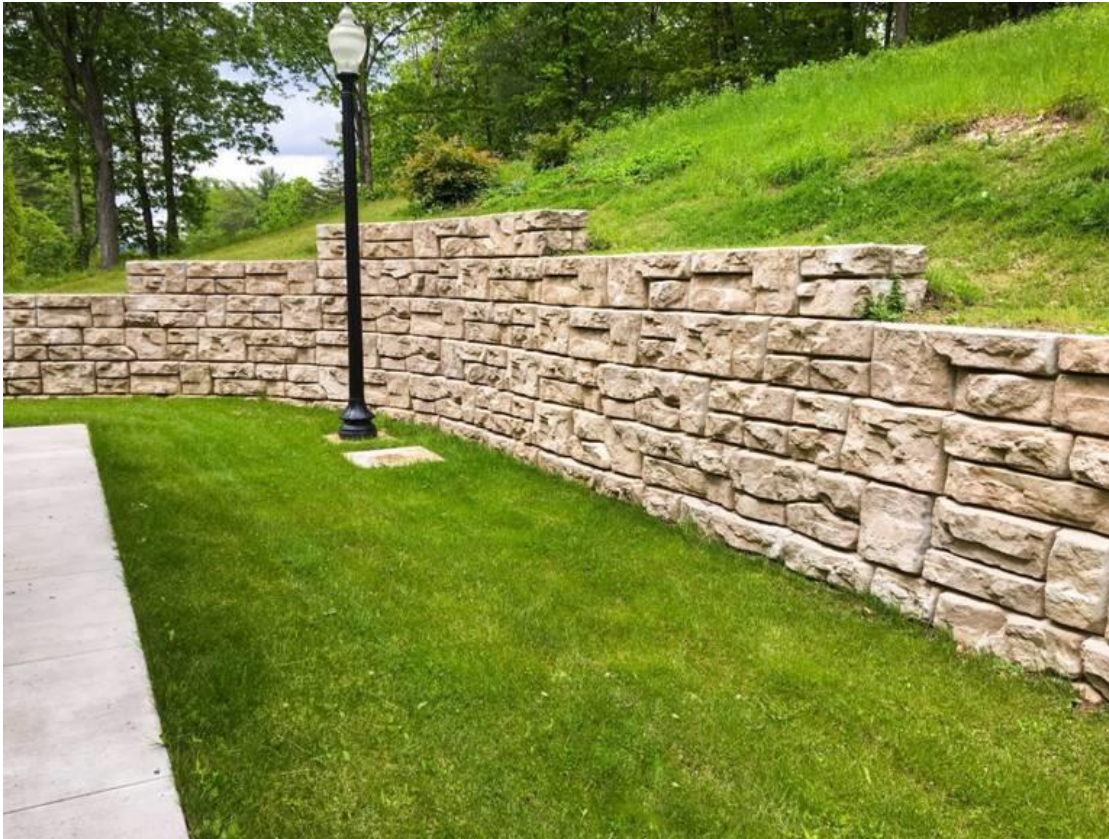
Replacement Redi-Rock Stone  
Ledgestone Option w/ Concrete Stain

- Reconstruct a modern wall with new, but visually similar materials.
- Salvage limestone from the retaining wall.
- Reuse material to repair other walls throughout the City.

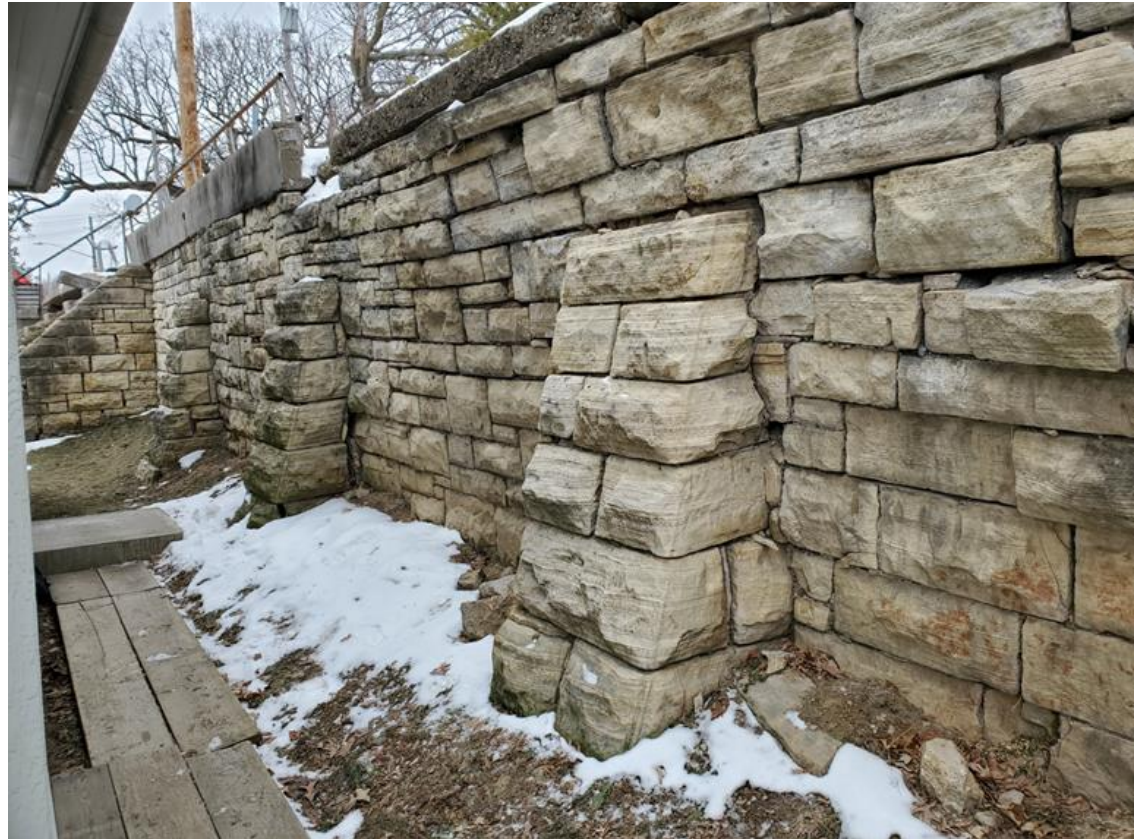
Existing Limestone Wall

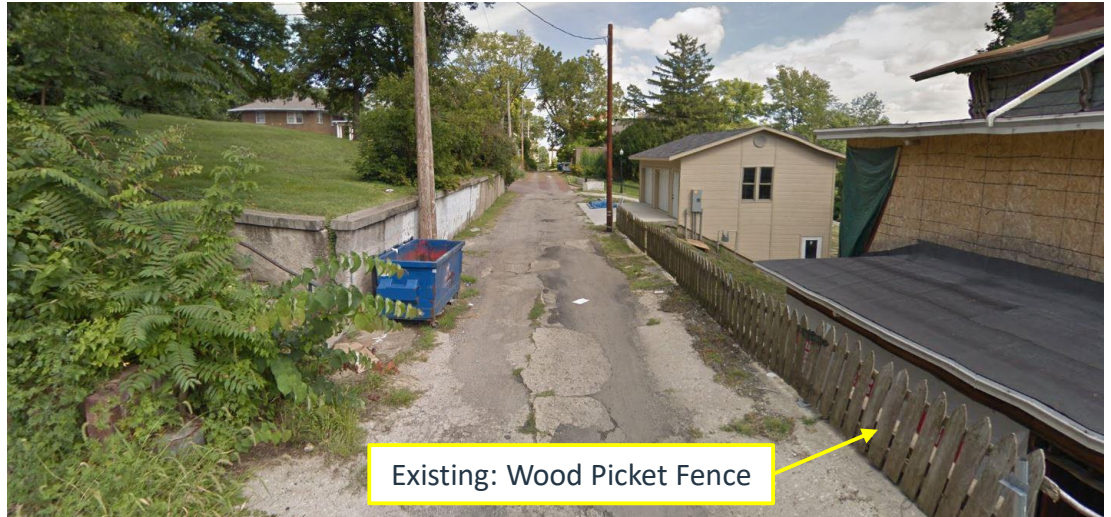
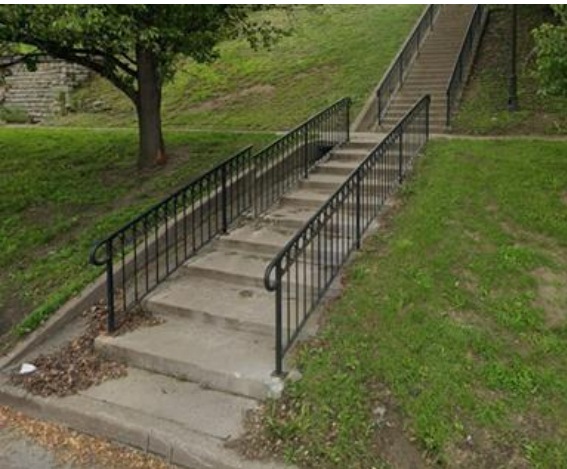
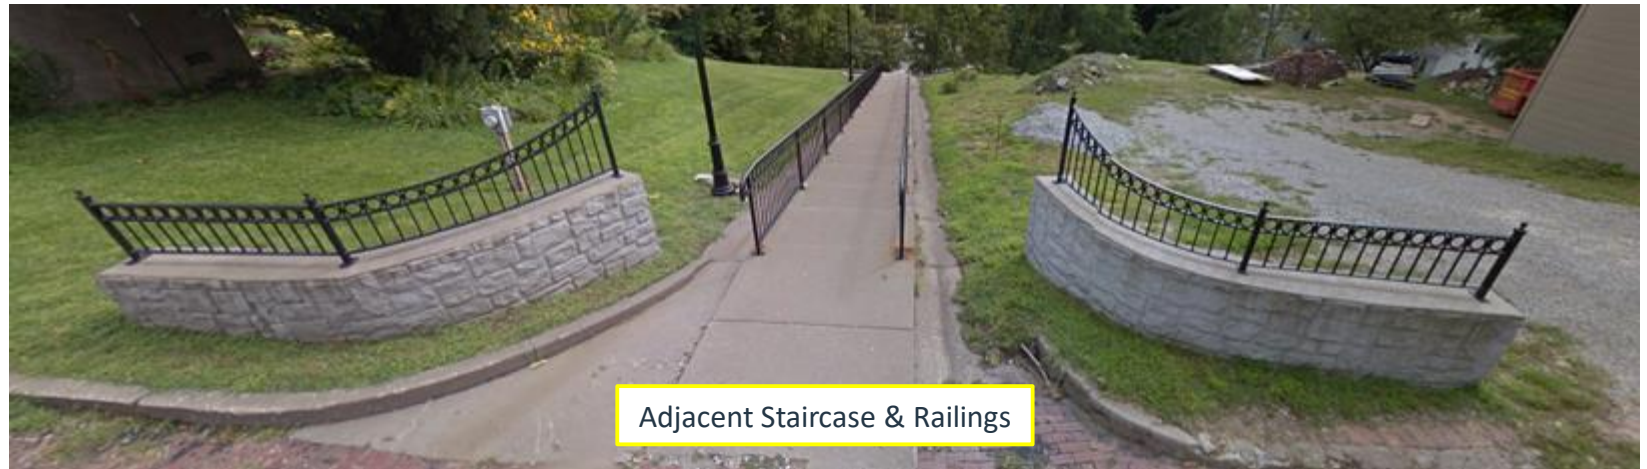
# Replacement Railing

- Existing Railing: Wood Picket Fence
- Proposed Railing: Black Coated Metal
- New Railing to Replicate the Material, Height, Color, and Design of the Adjacent Staircase Railing Connecting West 6<sup>th</sup> Street to the Alley
